Braunstone Village Conservation Area
CHARACTER APPRAISAL

2024

Braunstone Village Conservation Area

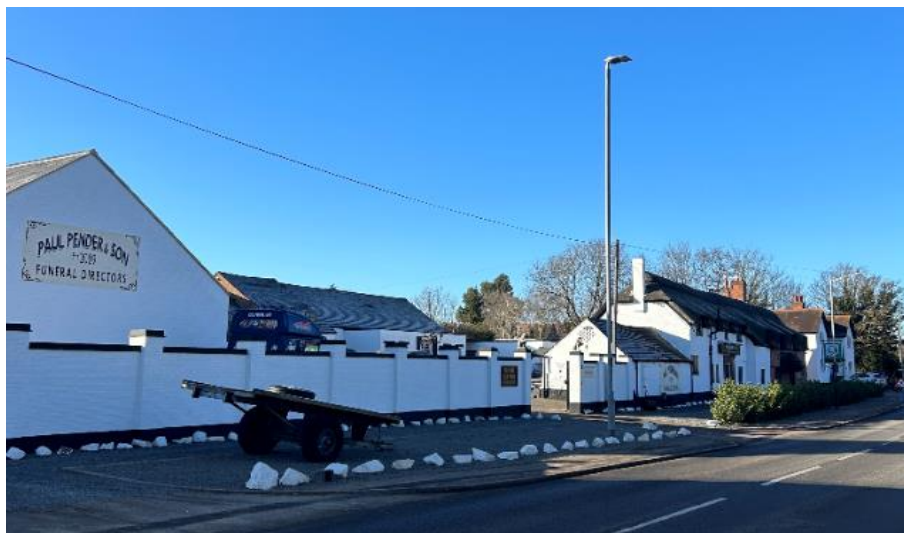
Image 8: The Shakespeare.

- 7.7 At the south-eastern end of the conservation is a complex of buildings, formally known as Ashleigh Farm, it is now called **The Shakespeare**. To the front of the plot, running parallel to the highway is the former farmhouse, the oldest sections of which is timber frame construction dating to the mid-17th century, with later alterations and extensions. The porch has the year “1655” recorded on its moulded lintel. The timber framed section contains brick infill in a mix of stretcher bond and herringbone patterns, and the building has been extended south in brick. The roof is thatched with a scalloped ridge and several thatched dormers. The Shakespeare and its curtilage are Grade II listed, designated in 1987.

- 7.8 The buildings to the rear of The Shakespeare form a courtyard of ancillary structures, formally part of a traditional farmstead. The original agricultural buildings have been altered and added to in recent years due to their change of use. The simple design and high-quality materials used have ensured the character of the former farmyard remains discernible. Worth noting is the stepped ridges of the south-west range which reflects the cumulative nature of the buildings and adds positively to roofscape in this area (Image 8).

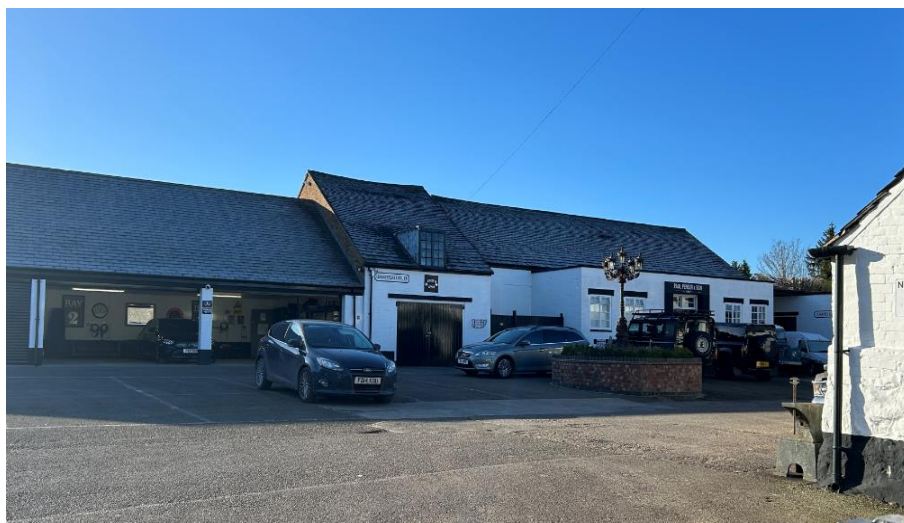
Image 9: The courtyard to the rear of The Shakespeare.

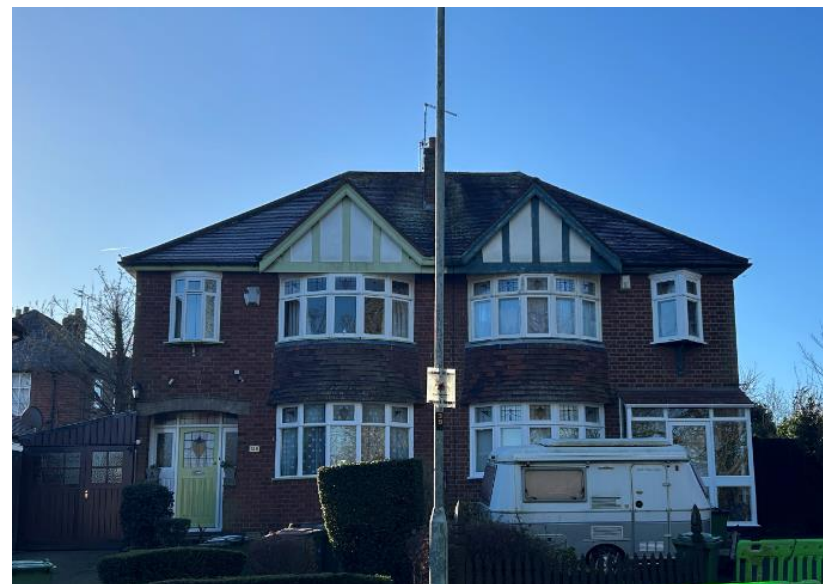
Image 10: 248 & 250 Braunstone Lane.

7.12 Nos **244 – 250 Braunstone Lane** are of a higher architectural quality than the other pair, with sophisticated oriel windows, faux timber framed gables, and double height tile hung bow windows. Almost all the properties retain their original timber joinery which makes an important and positive contribution to their appearance and group value.

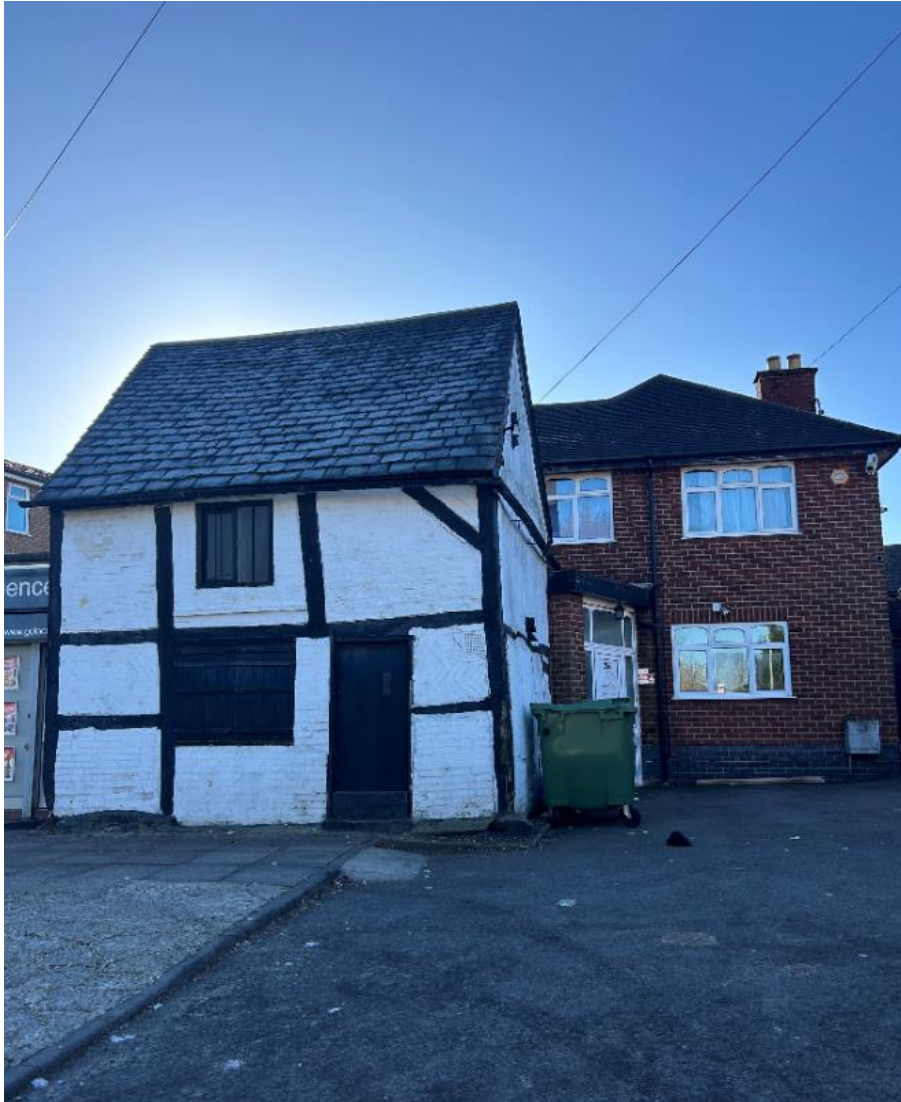
Image 11: Grade II Listed Former Shop with Storage Loft at 266 Braunstone Lane.

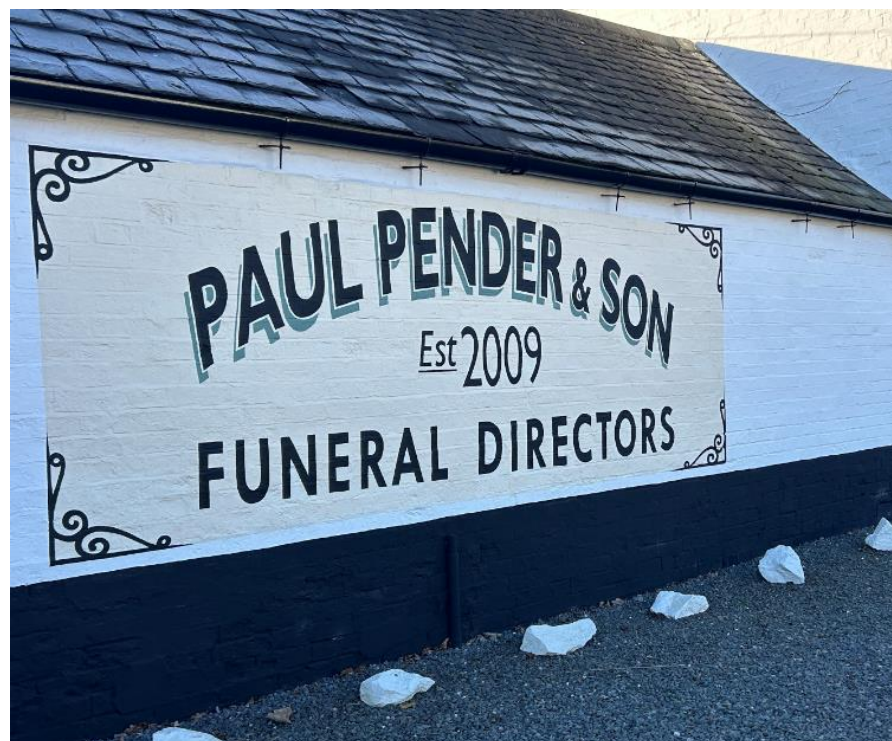
Image 14: Painted signage advertising Paul Pender & Sons Funeral Directors.

cohesive signage scheme which allows for the advertisement of the business while respecting the sensitive heritage setting. They have utilised a combination of contemporary and traditional painted techniques which balances well the needs of the business and the appearance of the building (Image 13). Notably, the former pub sign has been retained and sensitively amended, preserving this element of the building’s history.

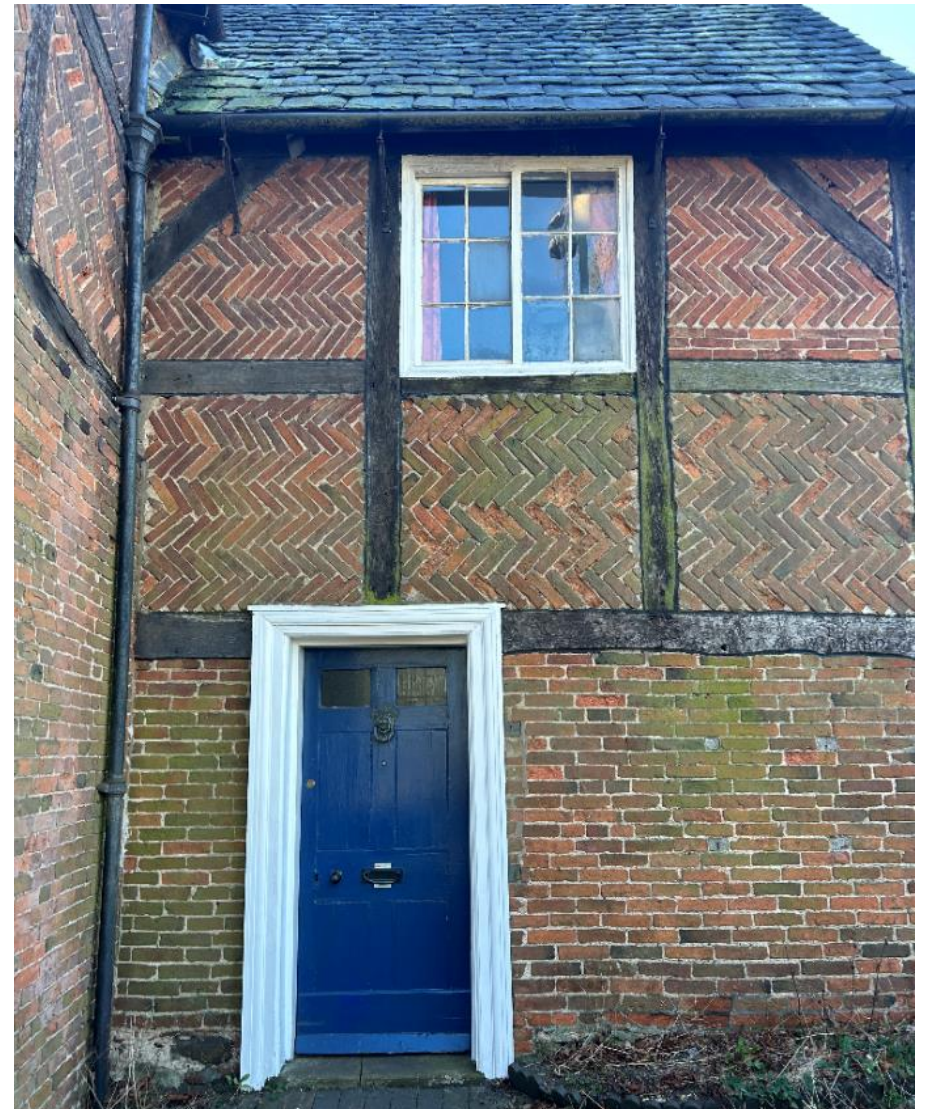
Image 15: The Manor, detail showing herringbone brick pattern, later inserted door and surround and vertical sliding sash window.

7.13 **The Manor** is a 17th century timber frame and brick farmhouse, which has been much altered and extended in several stages and over subsequent centuries. The inscription “16 WPM 89” survives on a timber rail. Sited perpendicular to the highway, its principal range is characterised by a prominent gable under a Swithland Slate roof, jettied first floor and later cantered bay window inserted to the ground floor. A secondary range extends north containing an 18th century flush panelled door and moulded architrave crudely cut into the beam above it. A 19th century brick and Welsh slate extension has been added to the rear with a set of four linked chimney shafts. The brink infill is a variety of stretcher bond and herringbone

pattern and there is a mix of window styles throughout the property including both vertical and horizontal slides sashes. The Manor and its curtilage are Grade II listed, designated in 1952.

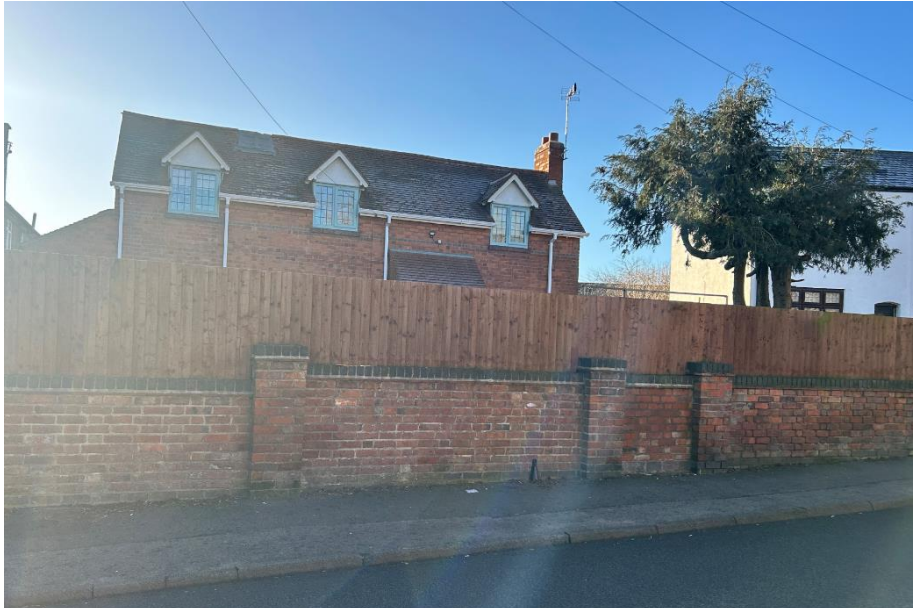
Image 17: Mixture of more and less traditional boundary treatments.

- 9.5 Boundary treatments throughout the Conservation Area vary and range in type, scale, and material, meaning there is a lack of overall consistency and cohesion.
- 9.6 Where present, front boundary treatments in the form of brick boundaries, timber fencing and trimmed hedges, provide a clear definition between the public realm and private property, creating a sense of enclosure and positively contributing to the local townscape. Decorative metal railings and gates are rare within the Conservation Area, with some examples found along Braunston Lane; however, there are instances of modern security fencing used in the vicinity of Shakespeare Park.

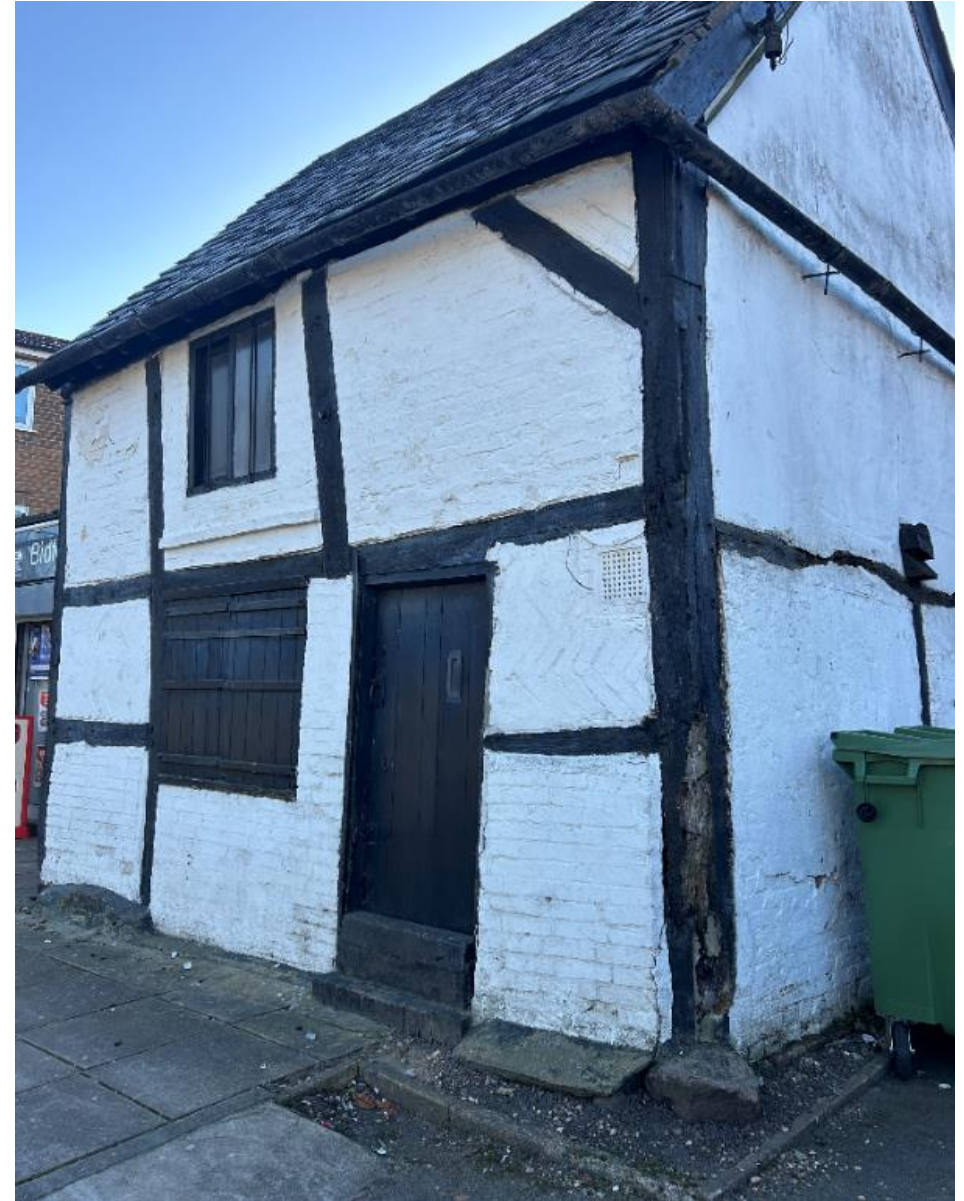
Image 19: Traditional materials use in the building with less cohesive floorscape materials below the plinth.

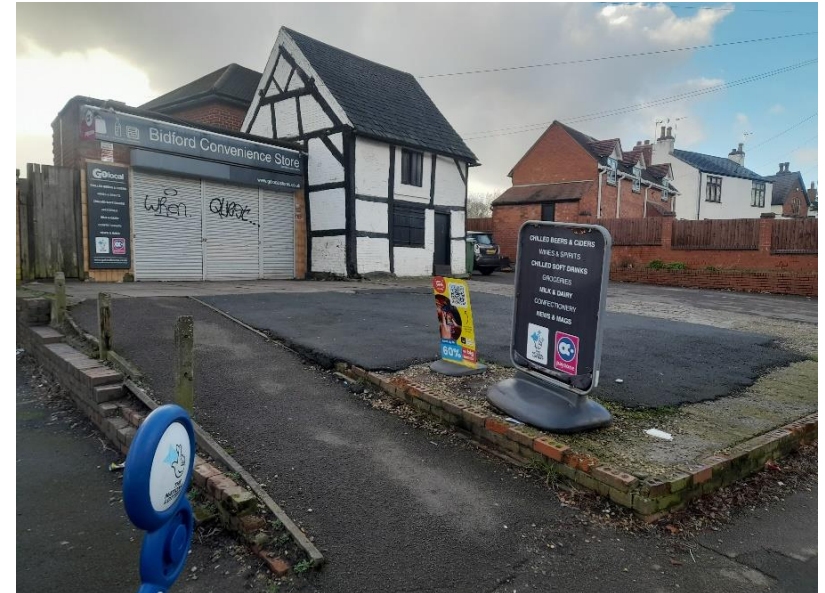
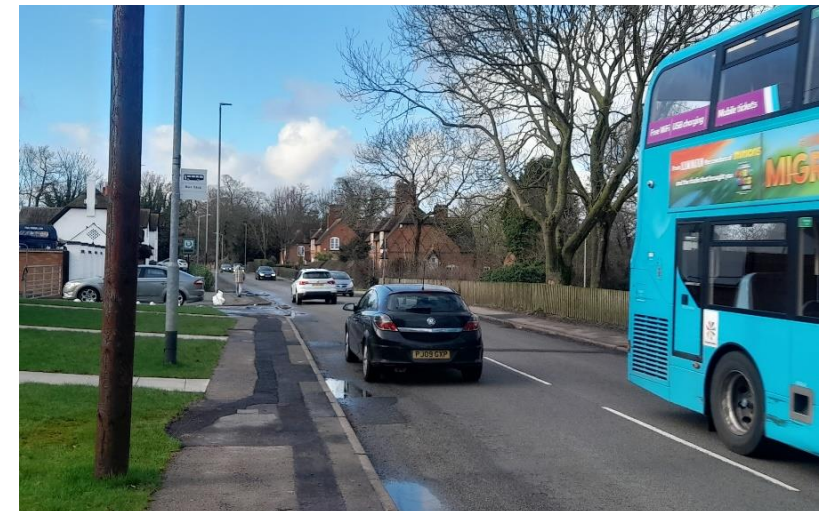
Images 23 & 24: Issues with boundary treatments and hard landscaping, as well as traffic on Braunstone Lane.

- 12.4 The inconsistent boundary treatments throughout the Conservation Area have already been noted but are worth highlighting as negative factors affecting the character of the area. Despite its compact size, the disparity of front boundaries is prominent, especially along the main thoroughfare of Braunstone Lane. Not only are the boundaries different in height, design, materials, and finish, but they are often incomplete, with notable 'gaps' punctuating the streetscene. This has caused visual disconnection between properties and obscured the definition of the private and public domain.

- 12.5 Traffic can dominate Braunstone Lane and make the experience for pedestrians and cyclists less comfortable. Sections of public pavement and highway along Braunstone Lane are in poor condition. In particular, the junction of Bidford Road, and the parking and forecourt area associated with 266 Braunstone Lane is dominated by mixed quality hardstanding. There is poor integration between different sections of hardstanding here, made worse by poor quality boundary treatments.
- 12.6 Commercial signage in this area is also of a more standard **quality** and does not reflect the sensitivity of its historic setting.
